2016 GOLD CIRCLE AWARDS

CASTRO ROOFING'S MASTERPIECE
SMU OWEN ARTS CENTER

2016 GOLD CIRCLE APPLICATION

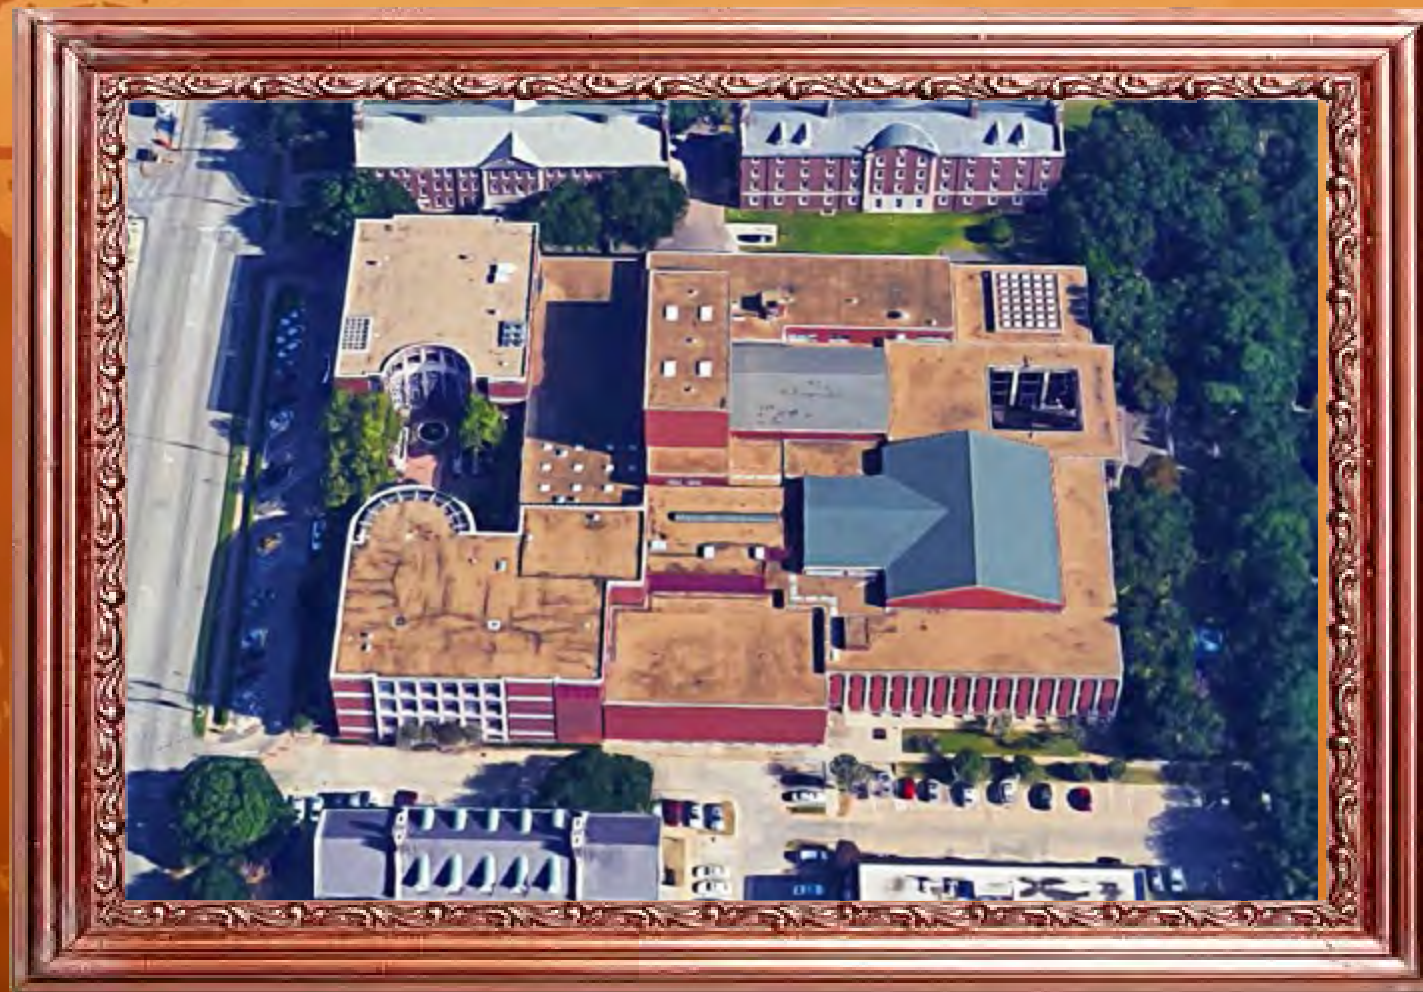
*Before Re-roof
Existing coal tar pitch*

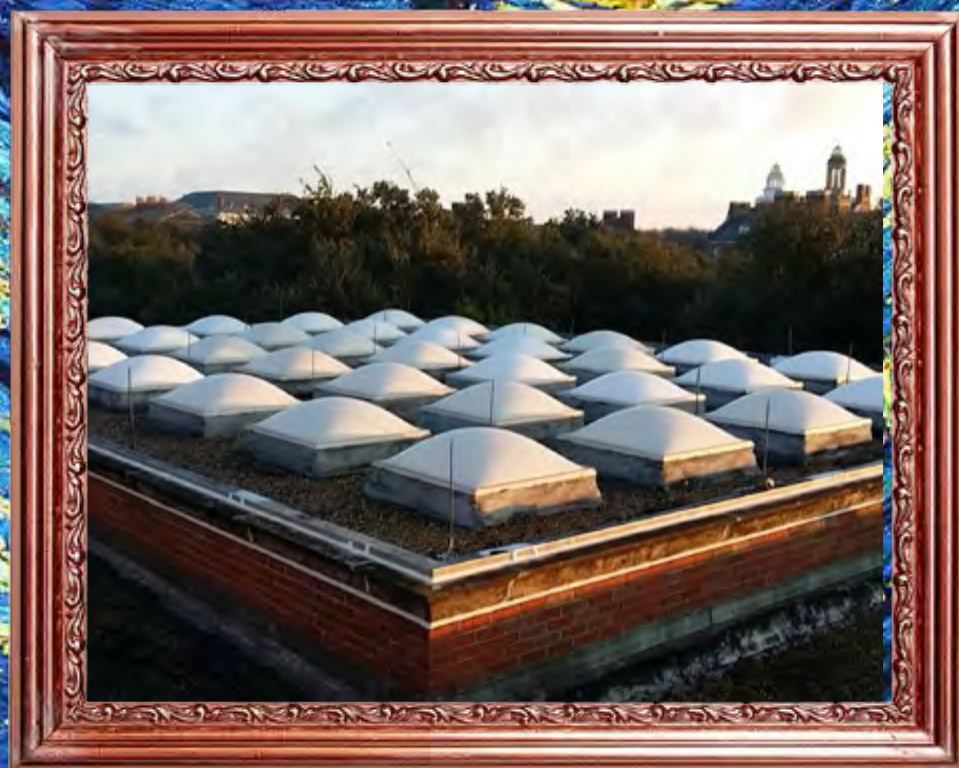
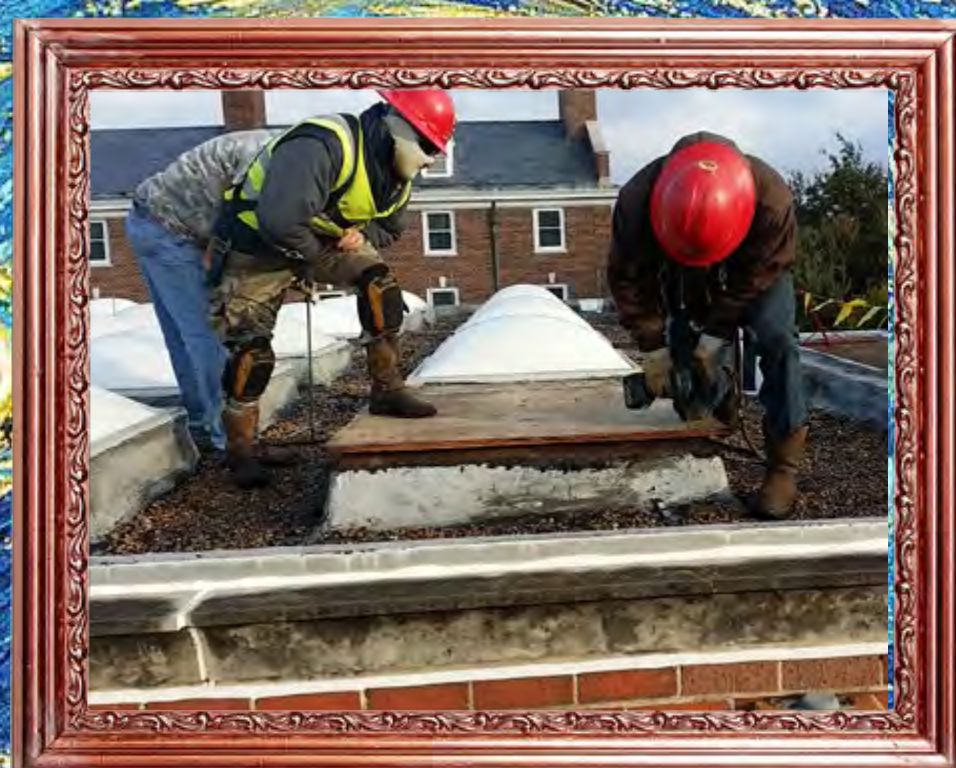
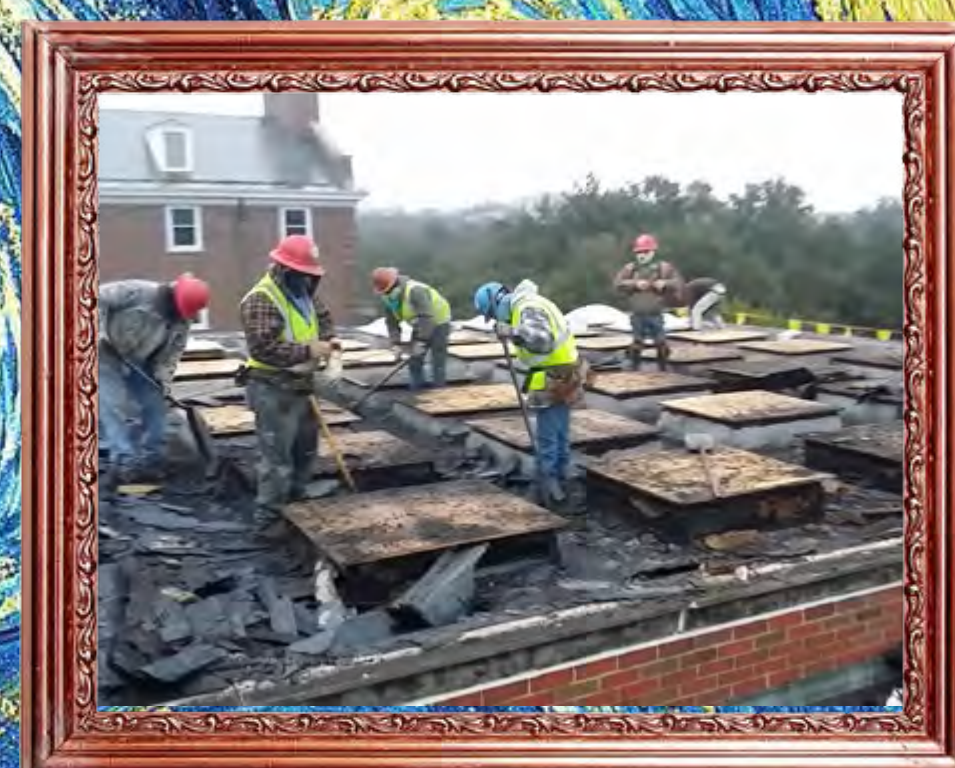
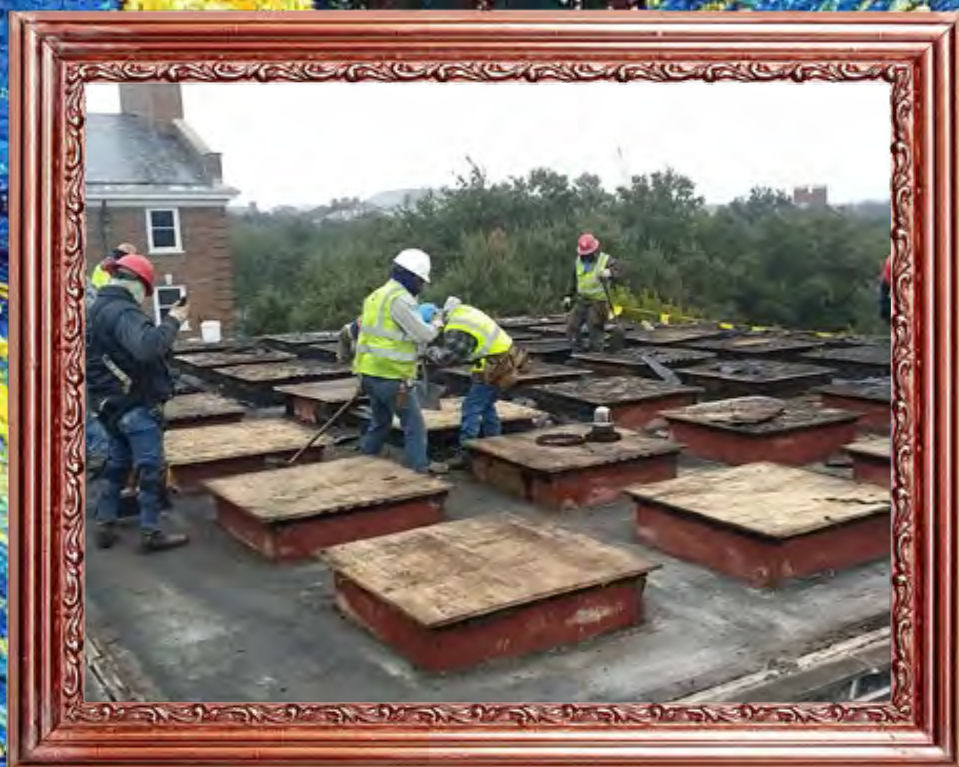
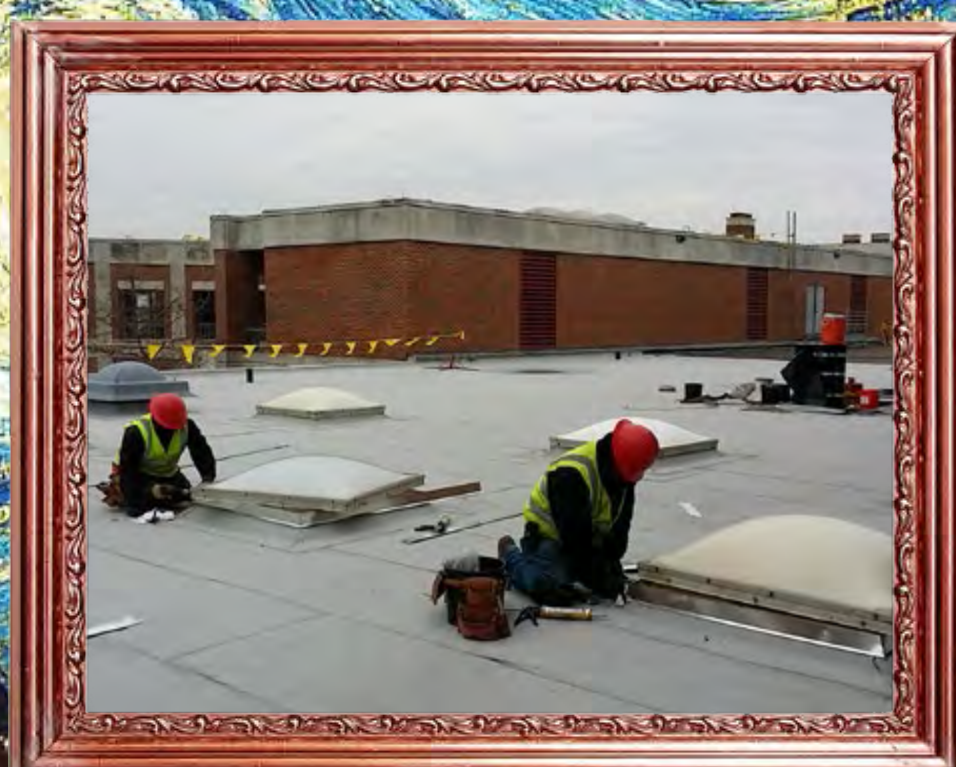
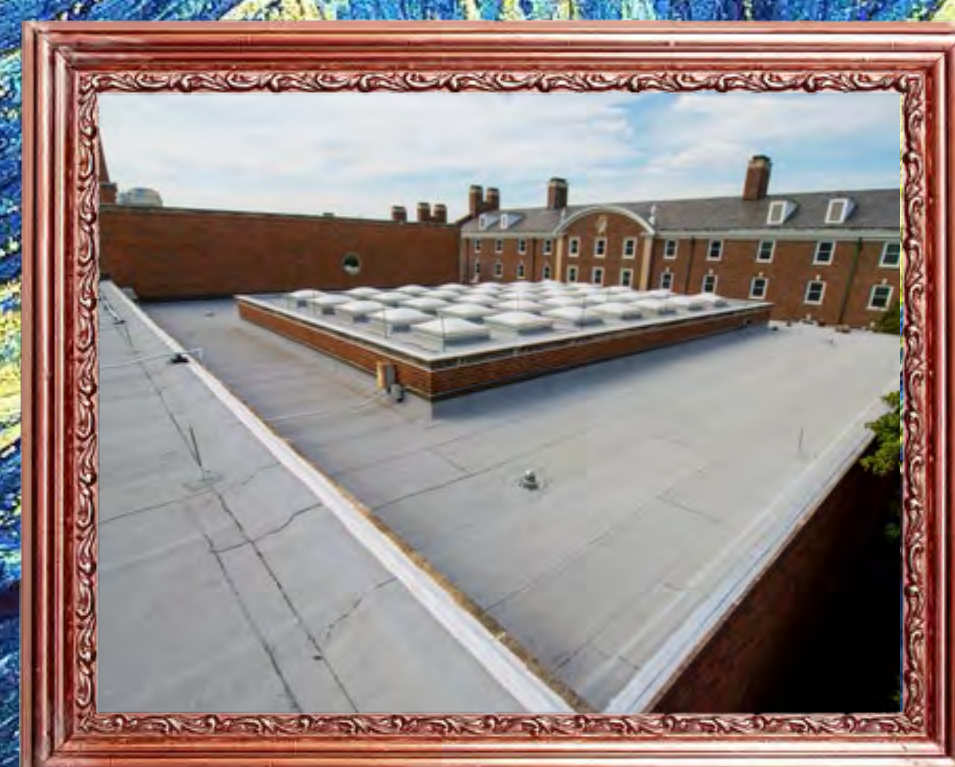
54 skylights out of 78 on the entire project were removed and replaced. Special care was taken at the interior during demolition so as to protect both the students and staff from any possible dangers.

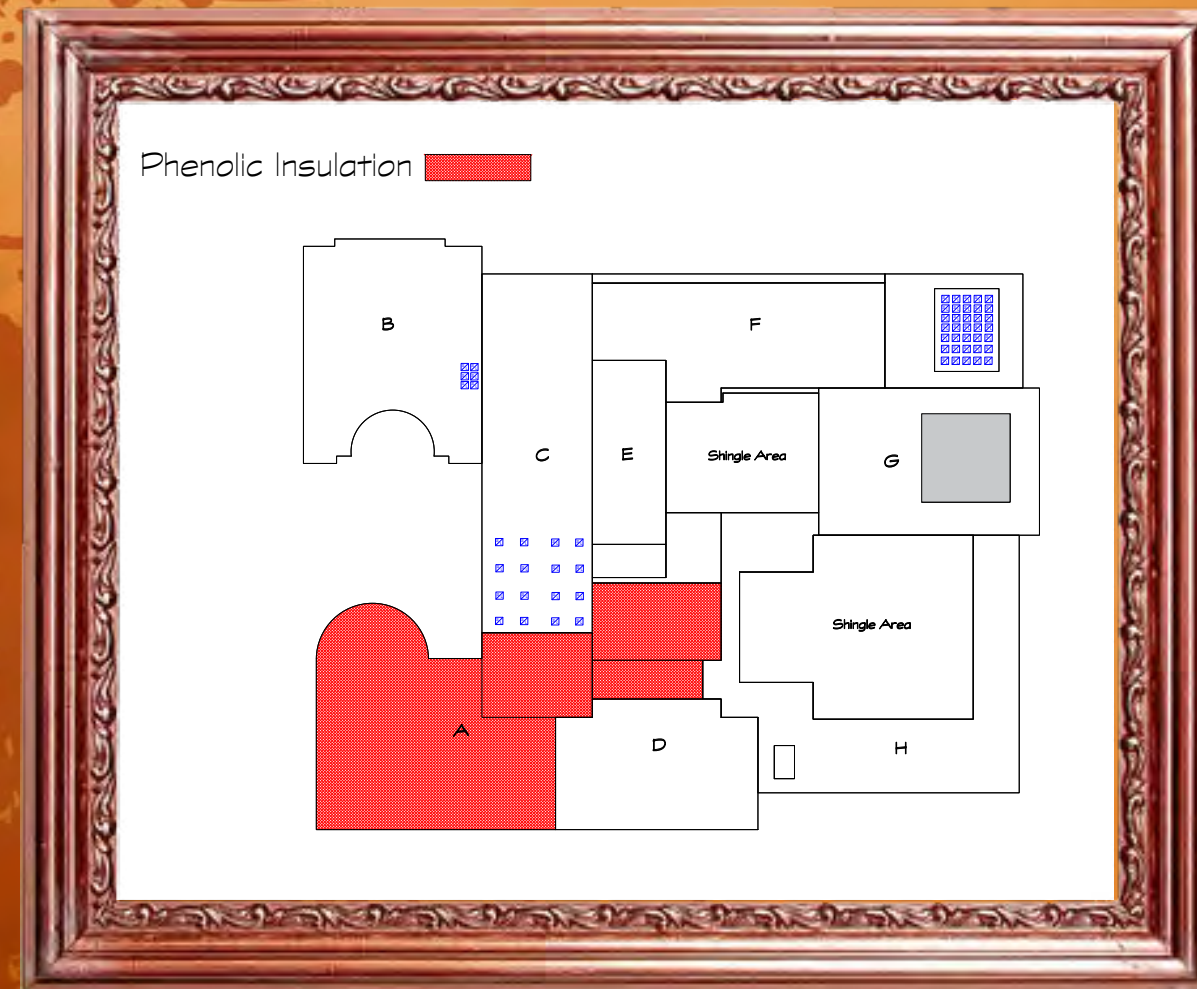
Multiple metal deck areas contained phenolic insulation, a very corrosive insulation when wet that can easily cause catastrophic metal deck failure. Fortunately the metal deck areas with phenolic were painted decks and not galvanized therefore no discernible damage was identified at these areas at the time of tear-off activities.

Phenolic insulation location

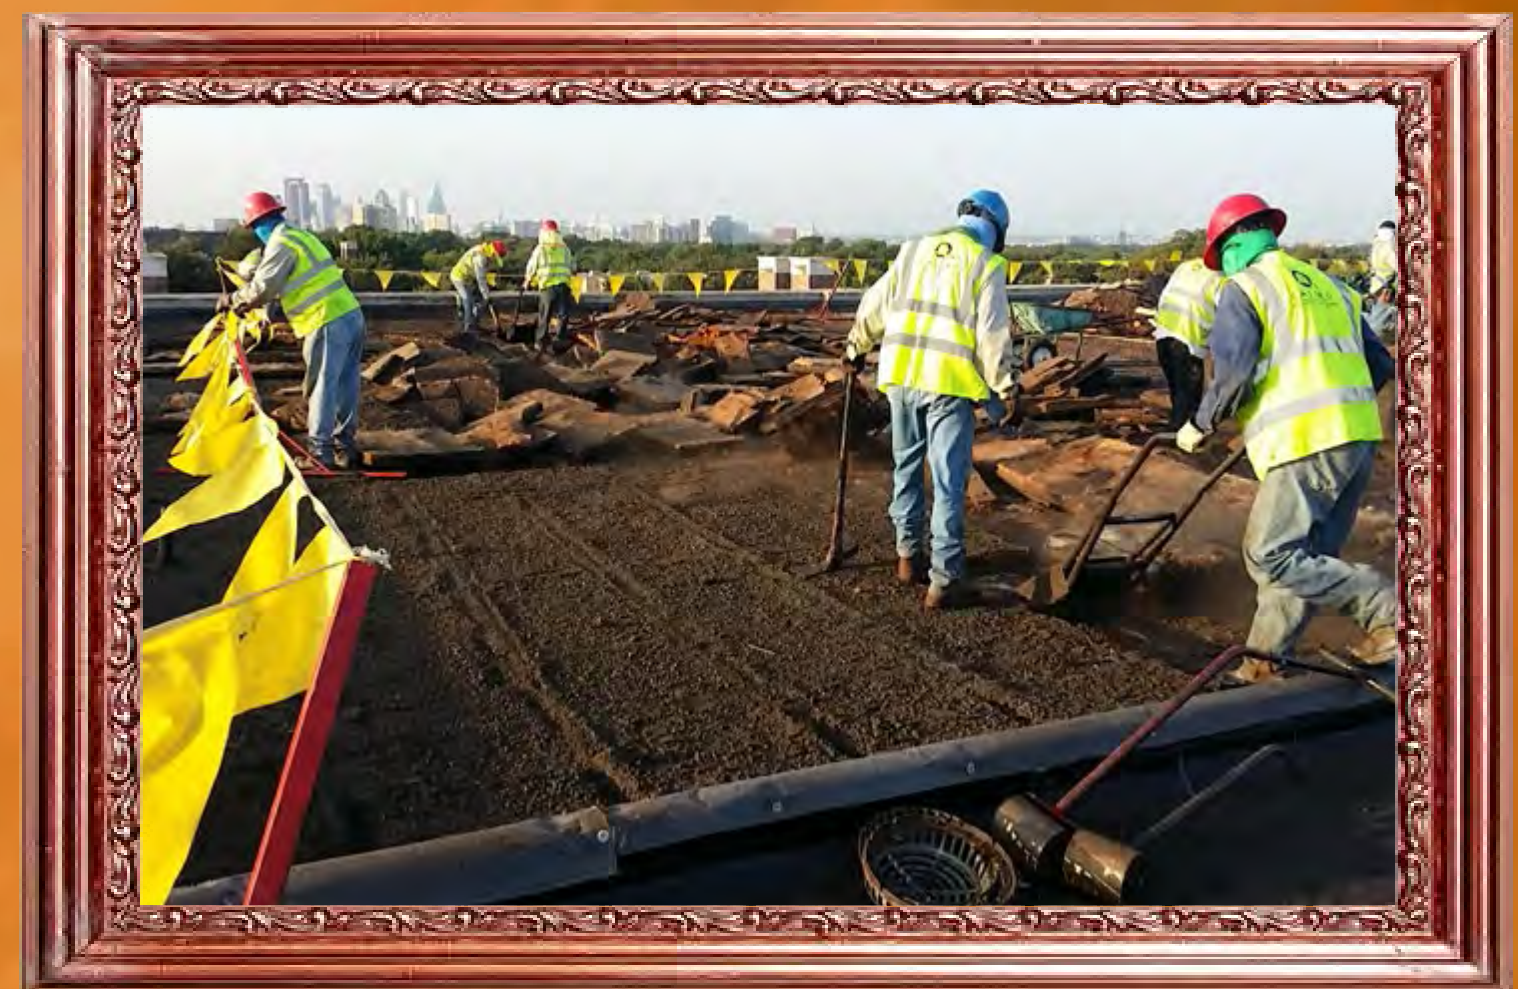
Removal of the phenolic insulation

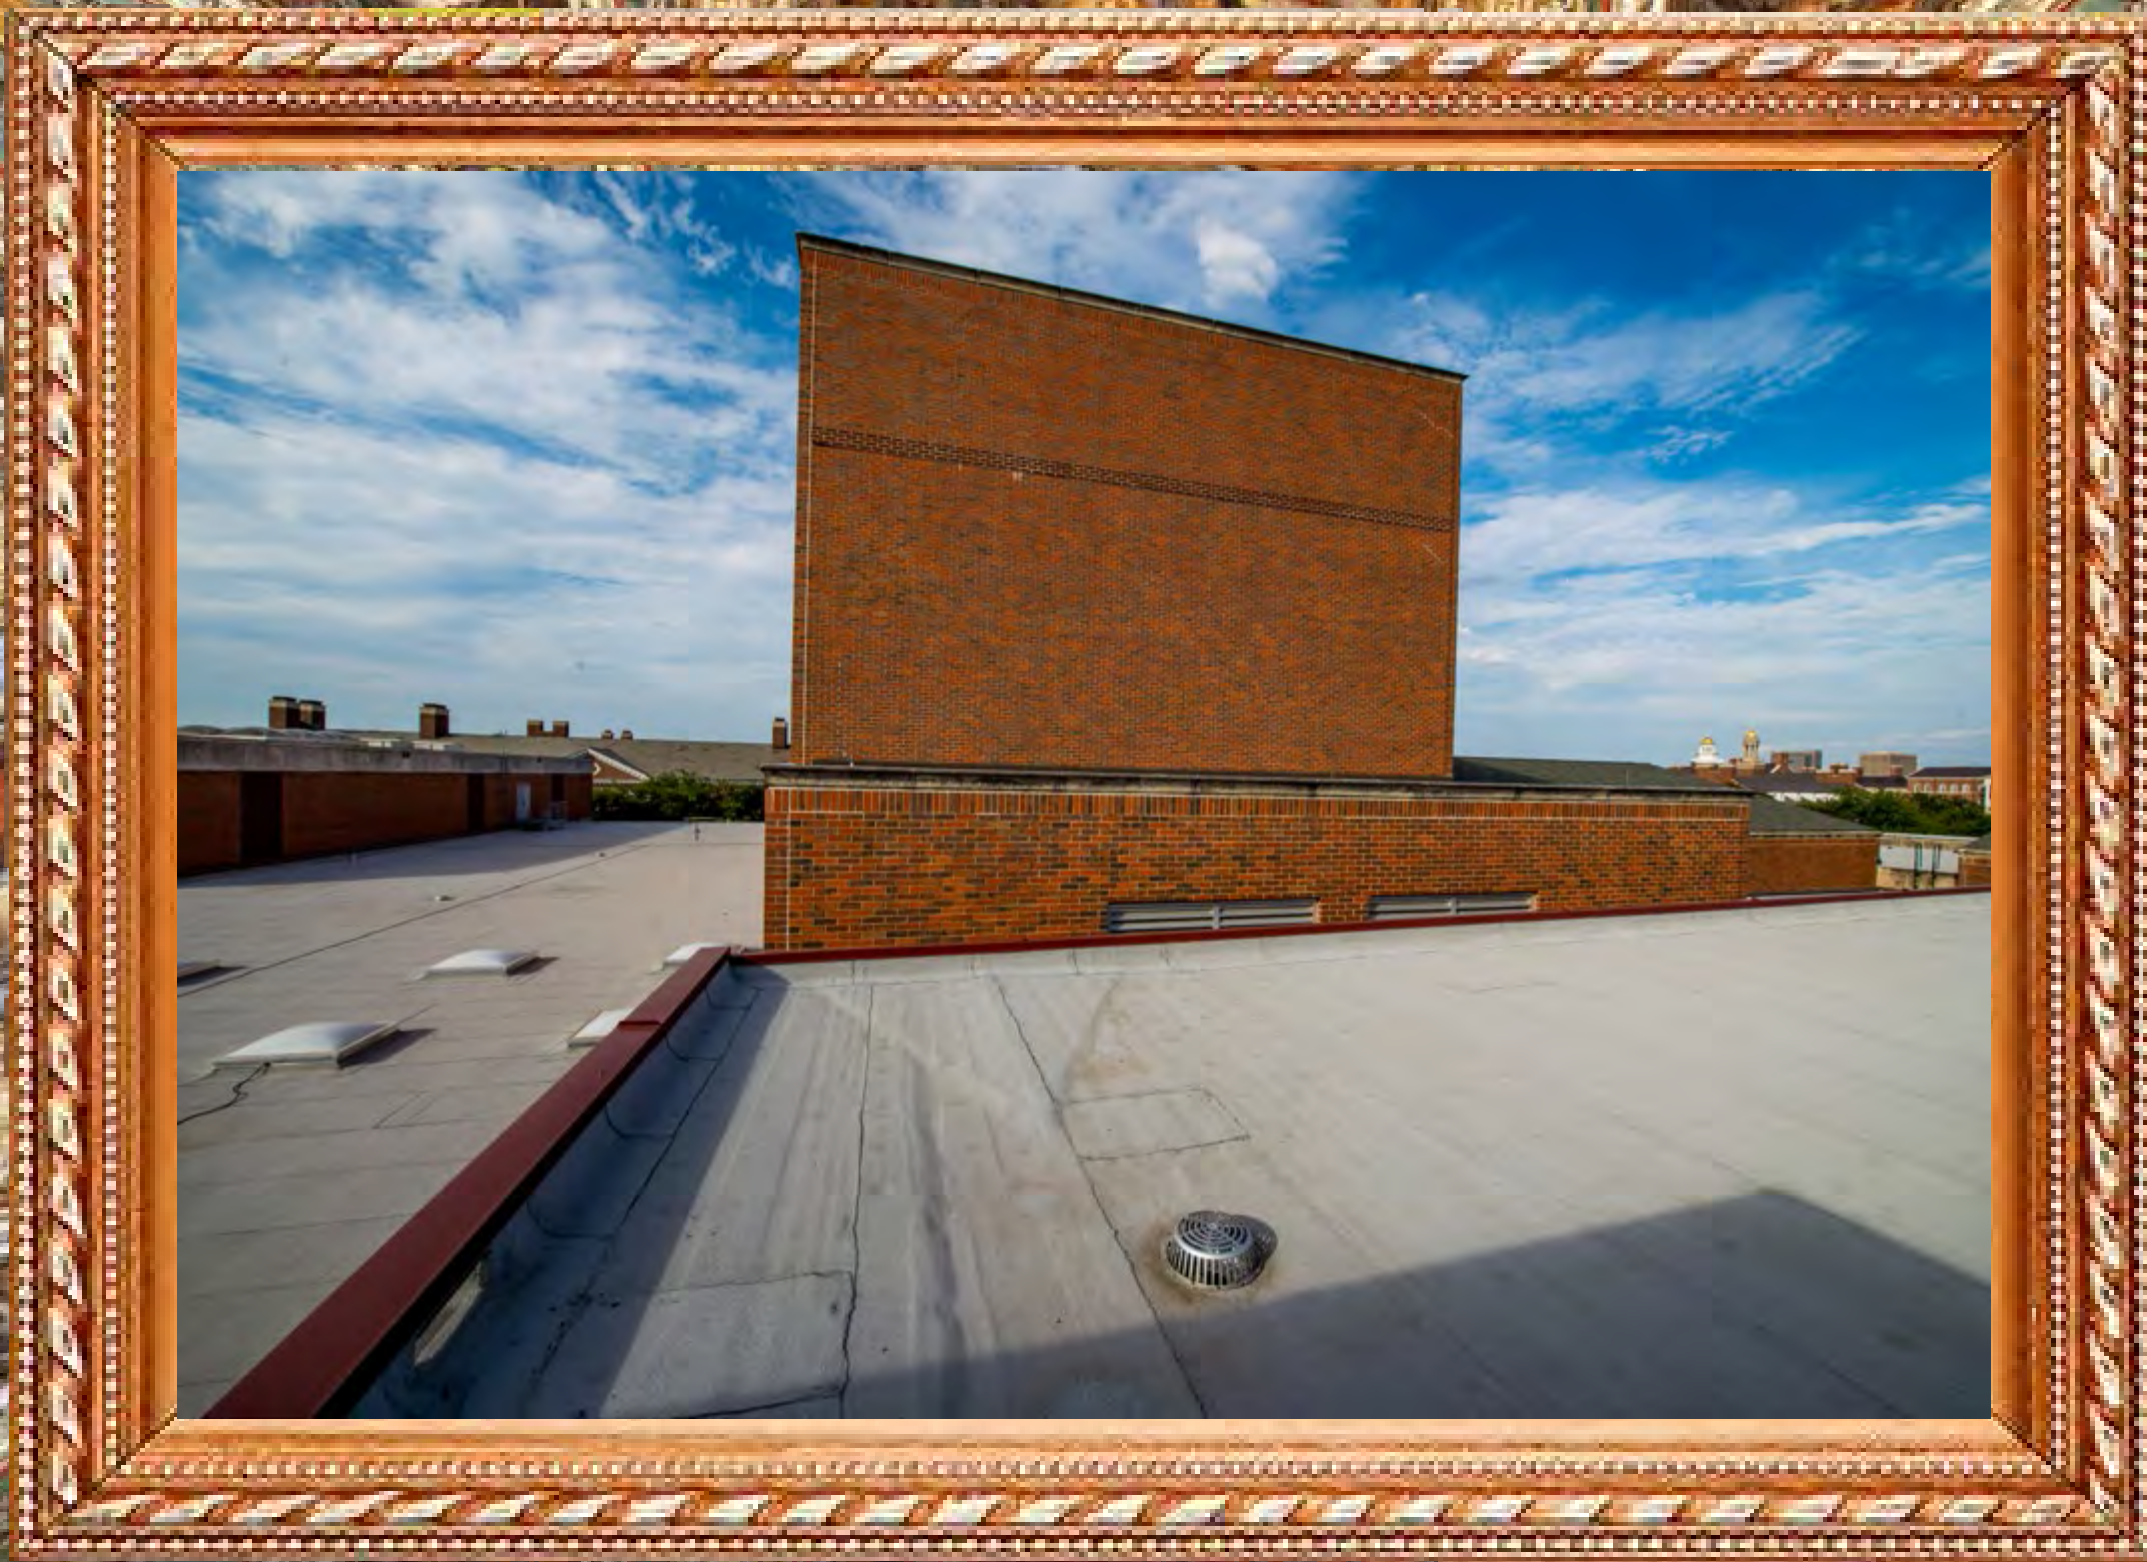
This area could not be reached by crane (located in the middle of the roof). A chute was constructed to lower all debris down to a lower level and from there carried to the one debris lowering site. A very long ladder was also used from roof level to roof level to reach this area as there was no interior access via roof hatch. A hoist was used to raise the needed materials to this high roof area.

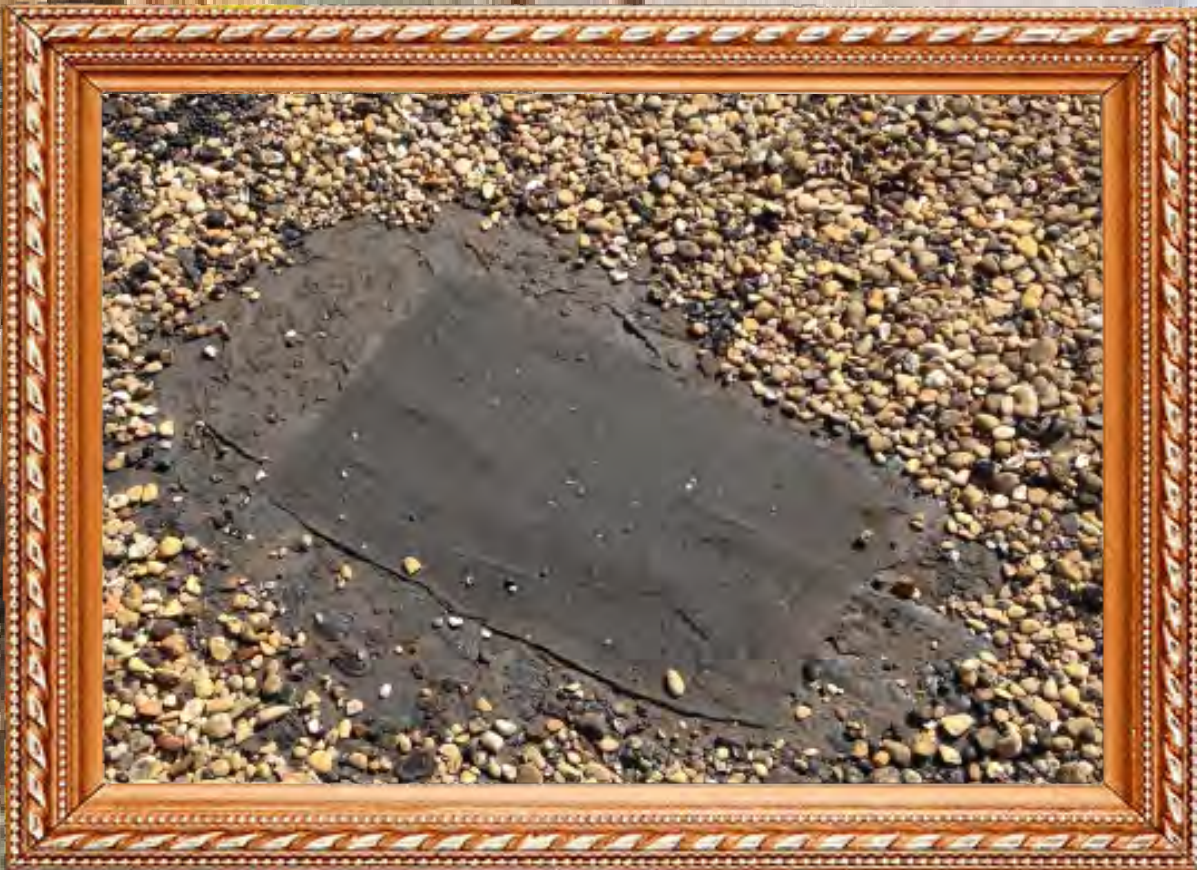
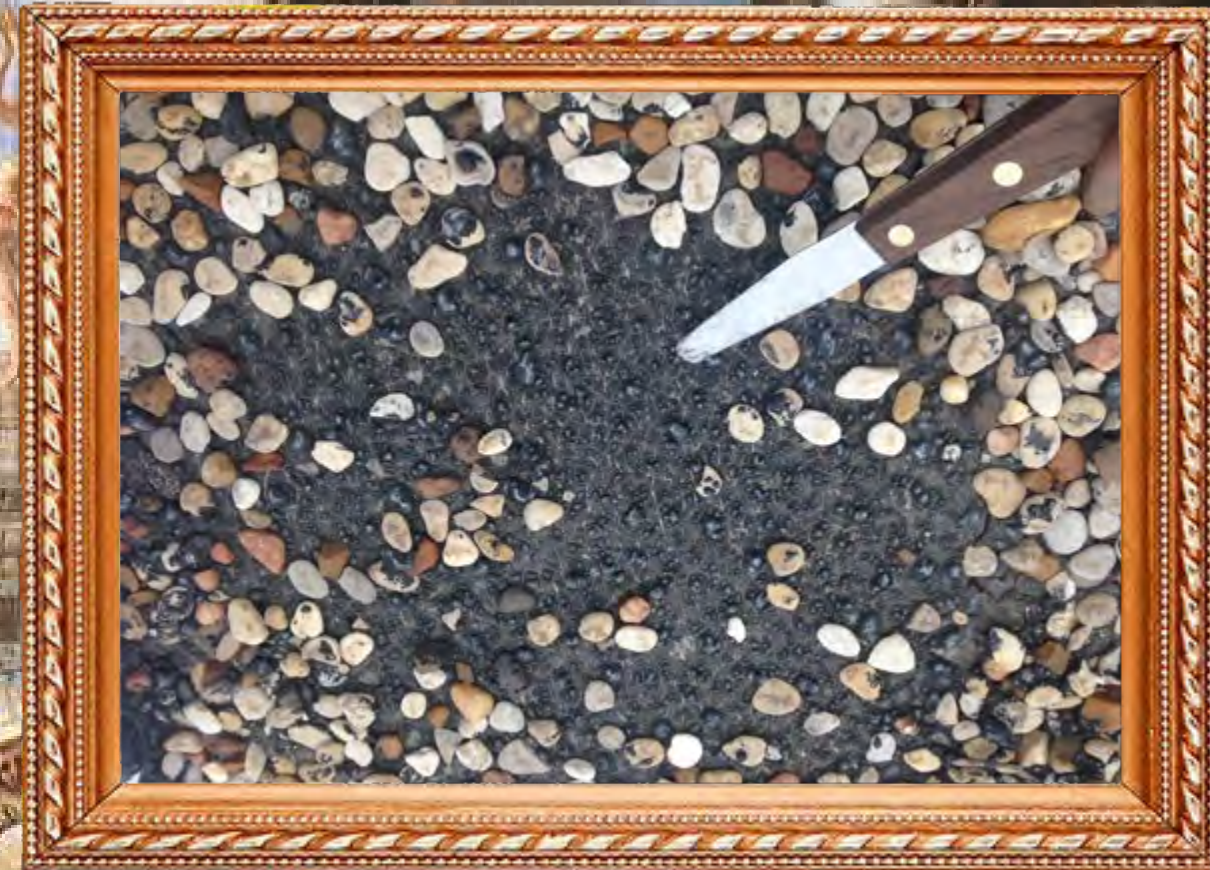
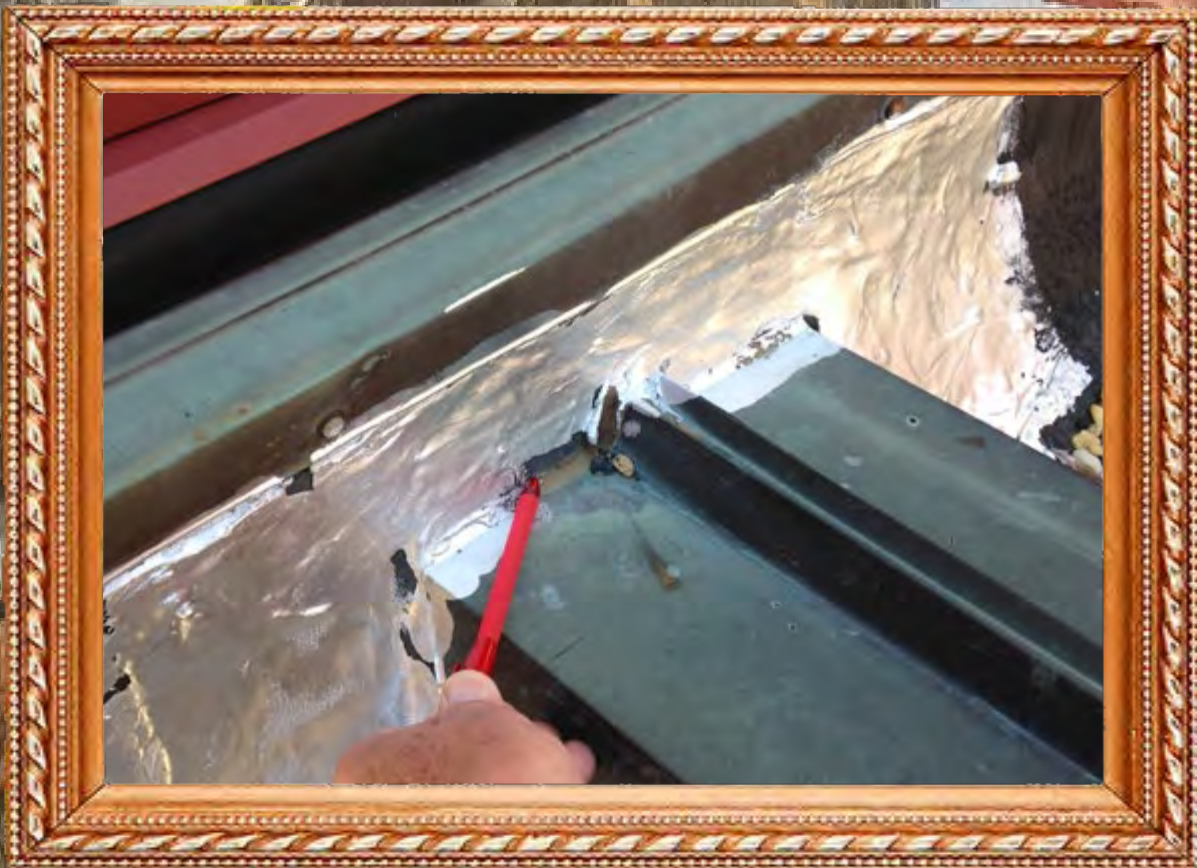
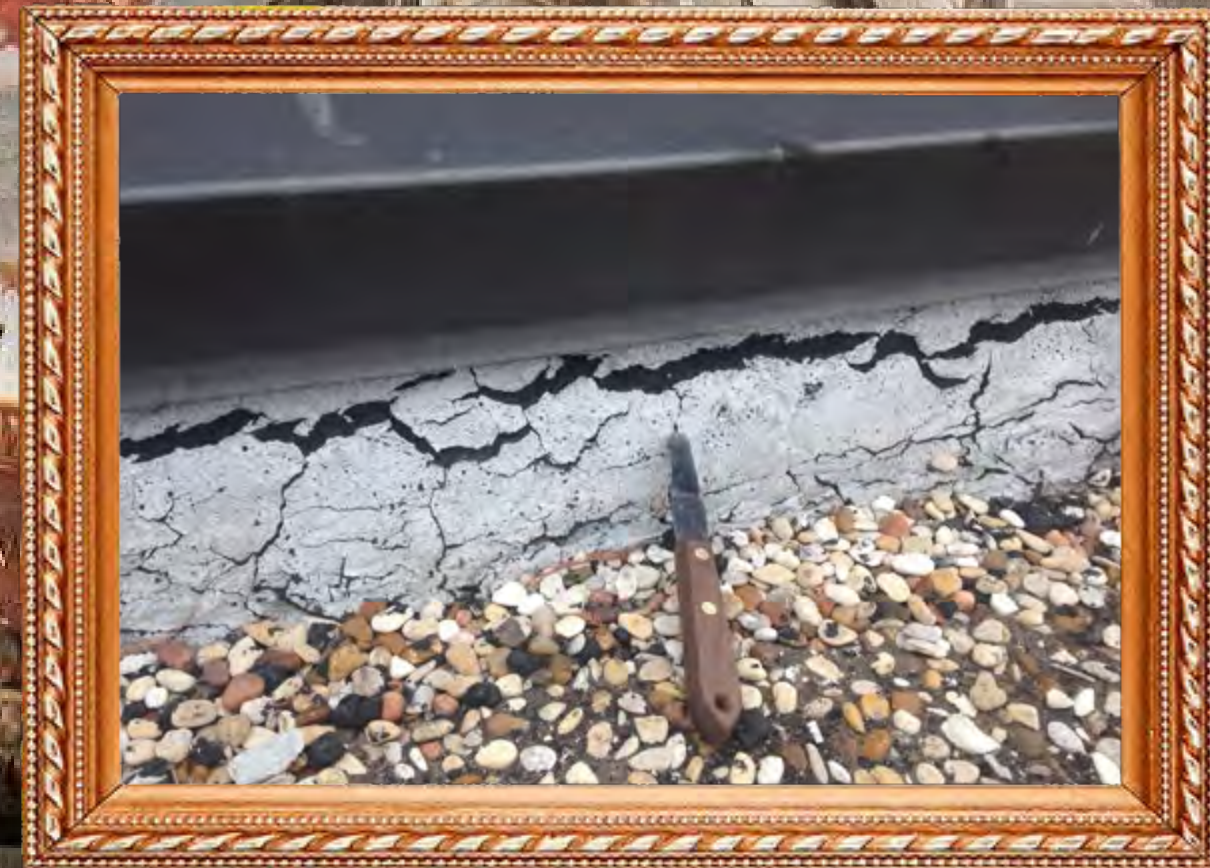
Existing coal tar pitch roof was improperly repaired causing pre-mature roof system failure

Coal Tar built-up roofing systems are considered the Mercedes of commercial roofing systems. The Coal Tar Pitch roof at Owen Art Center still had plenty of life left, but due to leak repairs being done incorrectly by other roofing contractors (using asphalt materials, leaving the felts exposed to the sun and not repairing the roof leaks) throughout its history caused the roof to fail prematurely.
