GOLDEN CIRCLE AWARD

HALL OF STATE

# 2012 GOLDEN CIRCLE APPLICATION

# GENERAL INFORMATION

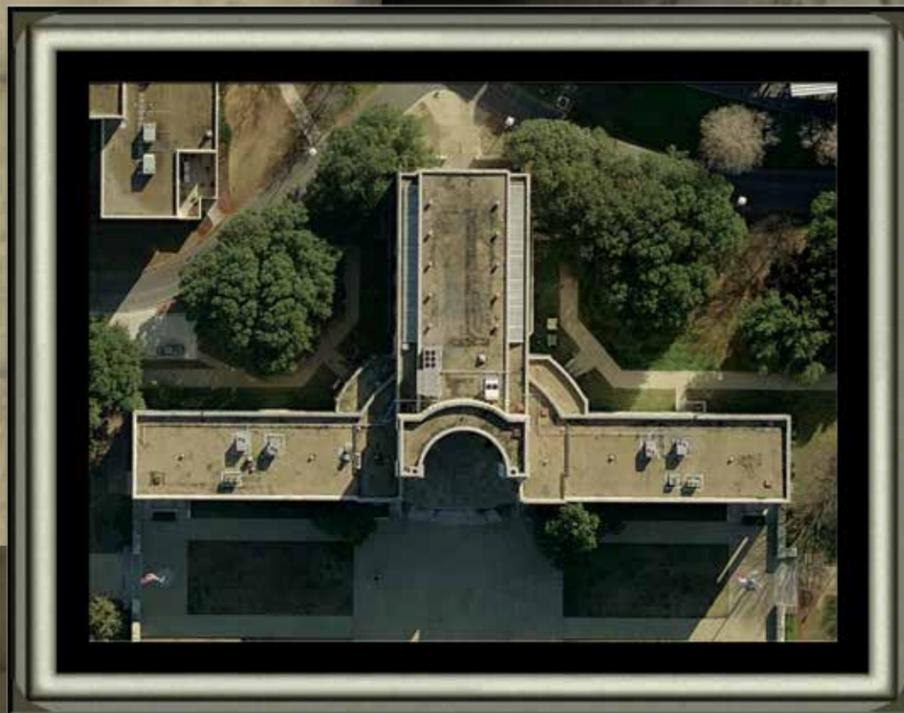
*The historic  
Texas Hall of State building  
before roof replacement construction*

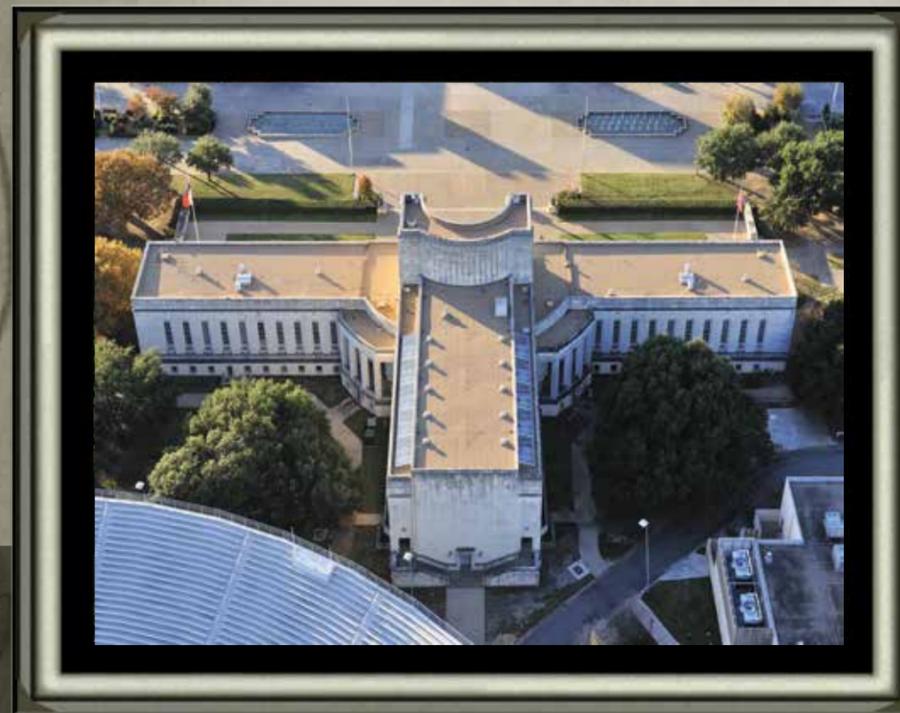
*The historic  
Texas Hall of State building  
after completion of roof replacement*

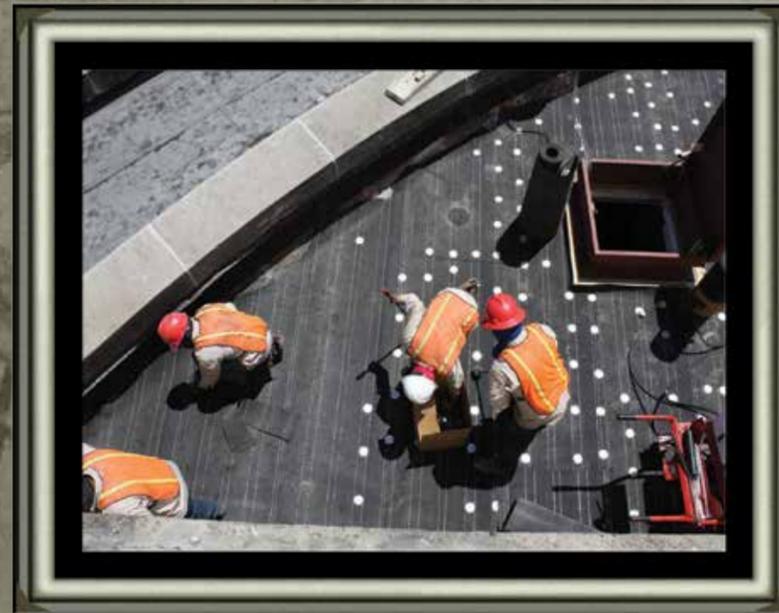
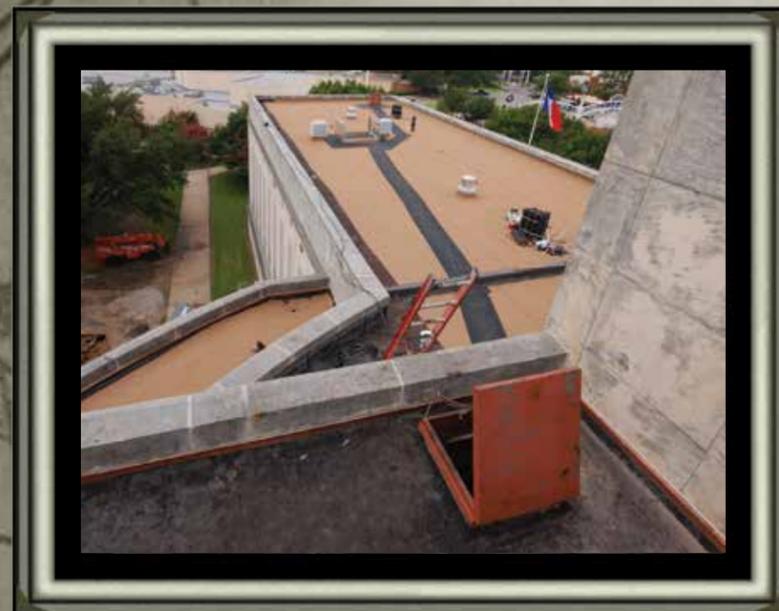
## UNIQUENESS ★ ROOF PLAN

The multiple elevations were another aspect of the Hall of State building that made this project unique.

The project contained eleven different roof elevations ranging from 15 to 50 feet tall, and in some areas the roof was reduced in size to a width of 18 inches. This made that particular area difficult to roof; on one side was a 30 foot drop, while on the other was a large row of skylights. Nevertheless, safety lines were secured and the project completed with no safety incidents.

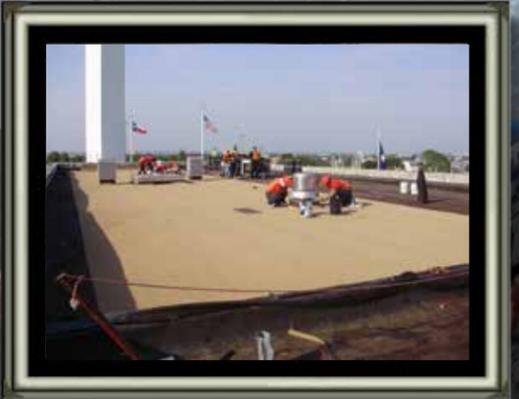
*Detail Work Done On The Finished Cap Sheet*

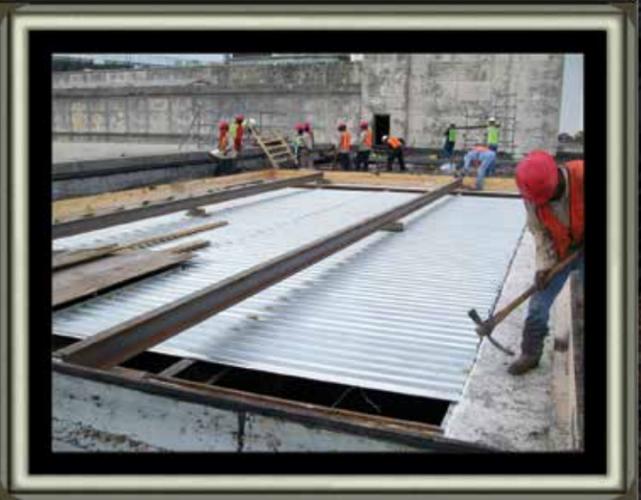
*Square Cut Into Existing Roof Kept Water Tight During Entire Project*

*Castro Roofing was commissioned to cut a square into the existing roof in the main hall to allow other contractors attic access to upgrade the electrical and mechanical systems.*

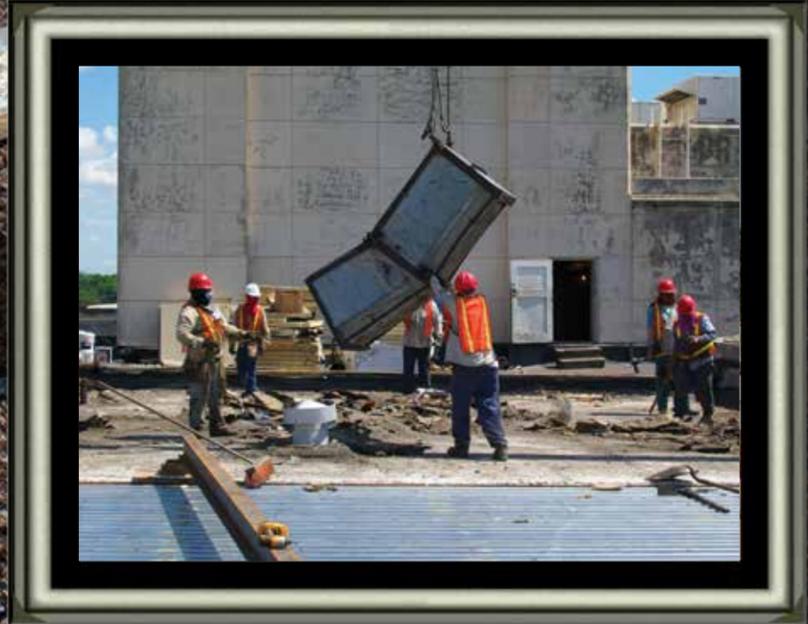
*Crane Used for Debris Removal*

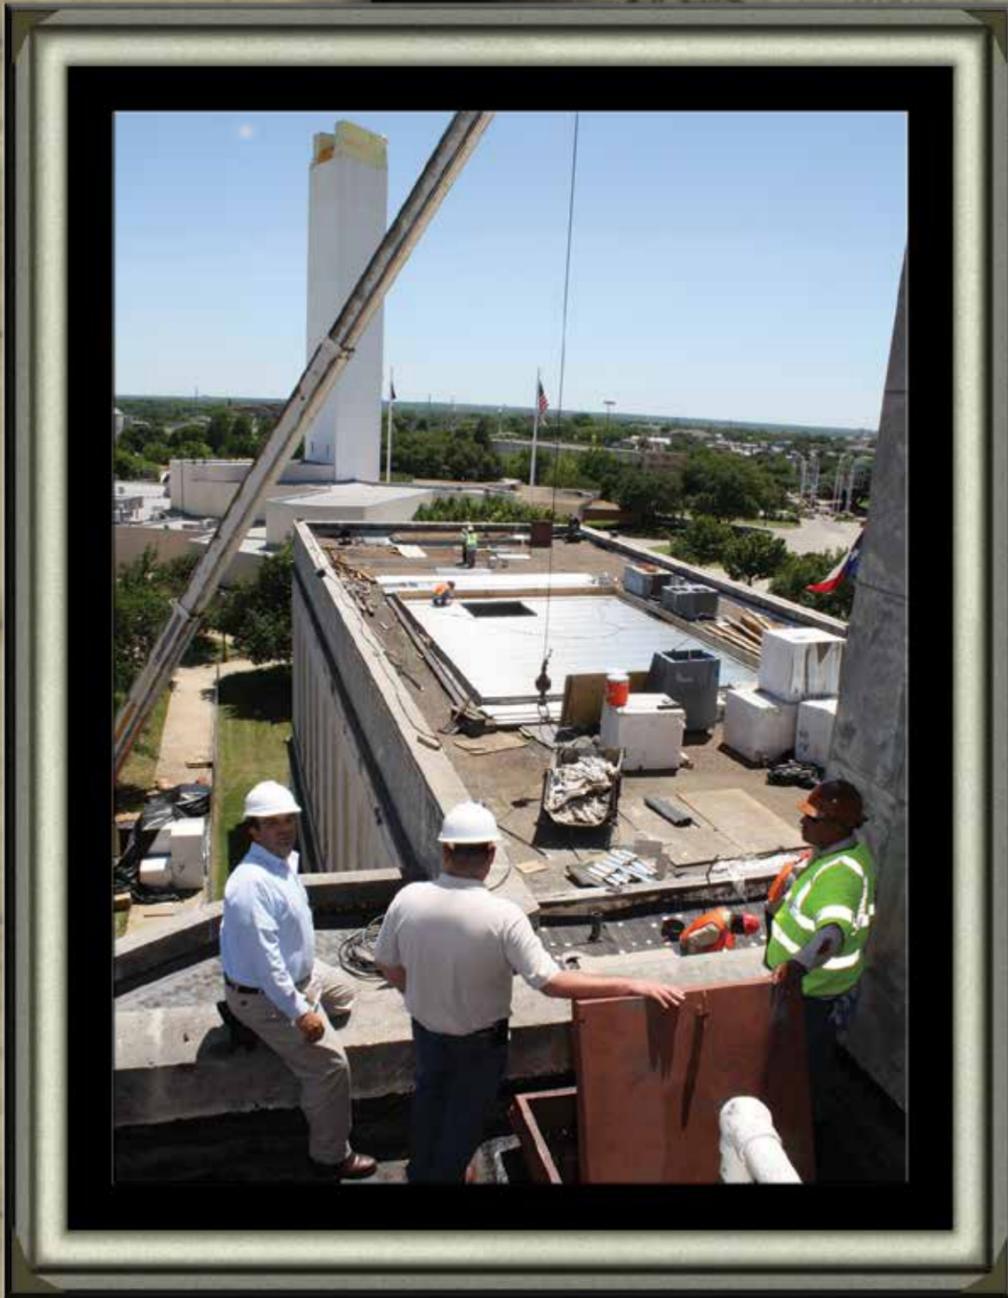
The Mezzanine portion of this project also posed a unique situation where holes had to be cut into the deck. No roofing contractor would ever purposely expose the inside of a building to the elements, especially this particular building. Nevertheless, six large holes measuring roughly 4' x 4' to 16' x 30' were cut through the gypsum and concrete decks in order to allow access for other sub-contractors to work the interior of the building, leaving said interior completely exposed for short periods of time.

Castro Roofing's role involved fabricating a temporary wood curb with intermediate wood cross members while using plywood and an EPDM membrane to cover the roof. A temporary tie-in was also prepared and attached to the existing old gravel roof system.

This temporary system subsisted for several months until the interior work was completed. Afterwards, a 22 gauge galvanized metal deck was inserted and filled with insulation to the level of the rest of the decking before the rest of the roof system was installed.

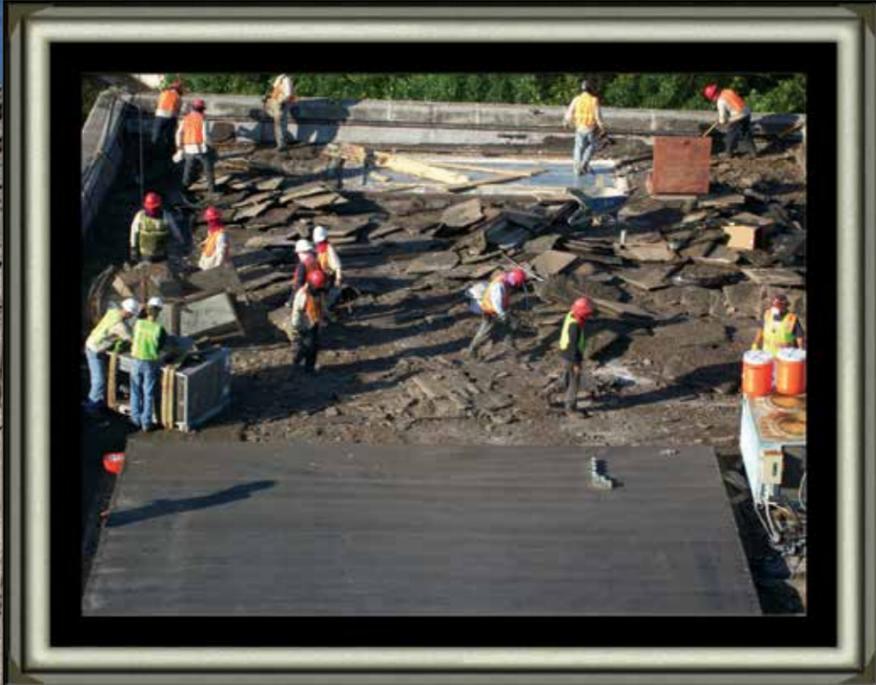
*Tear-off of Existing Roof*

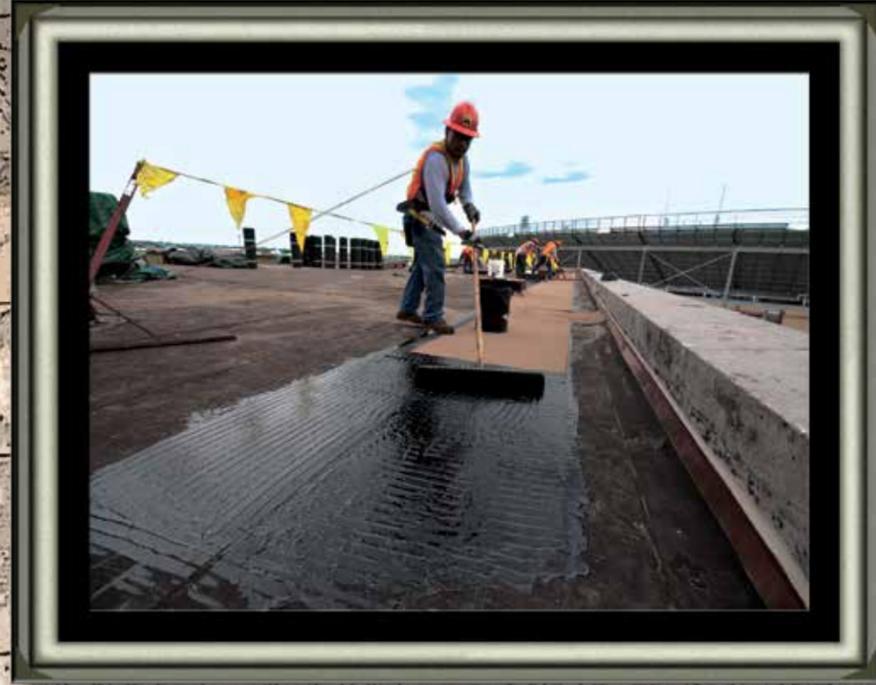
*Cold Process of Cap Sheet Instal*

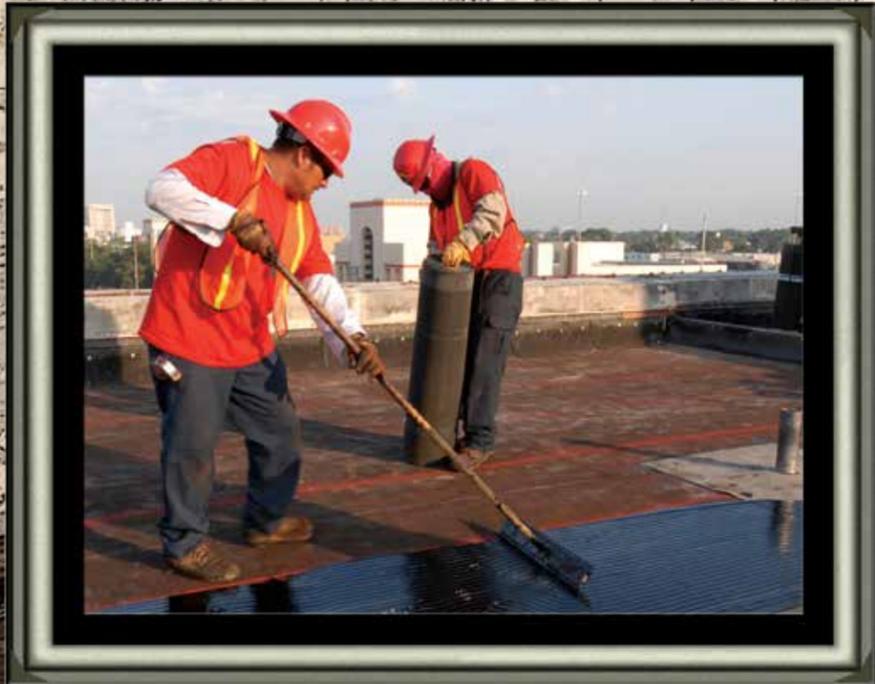
*Cold Process Under Roof Application*

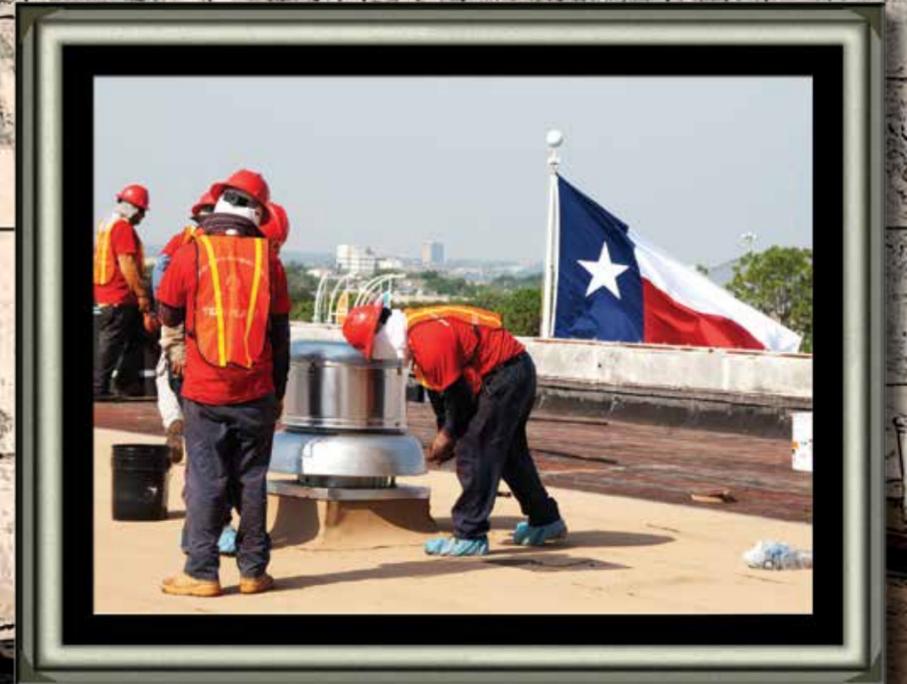
*Detail Work Around Exhaust Fan*
