2016 GOLD CIRCLE AWARDS

CASTRO ROOFING'S MASTERPIECE
SMU OWEN ARTS CENTER

2016 GOLD CIRCLE APPLICATION

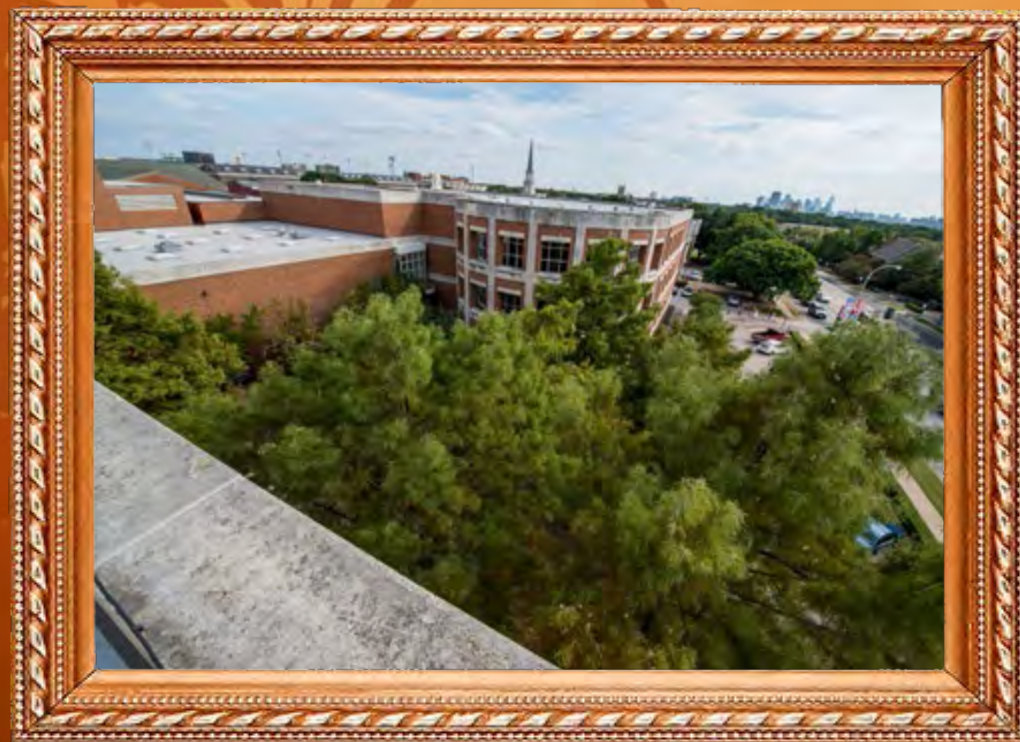
Impossible staging area

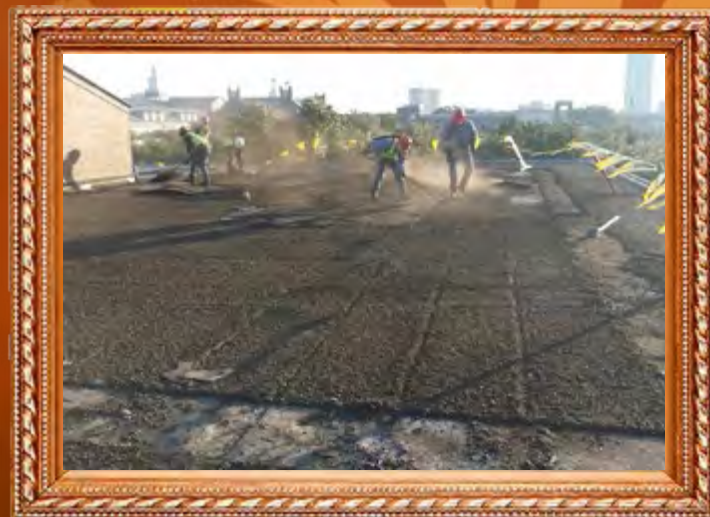
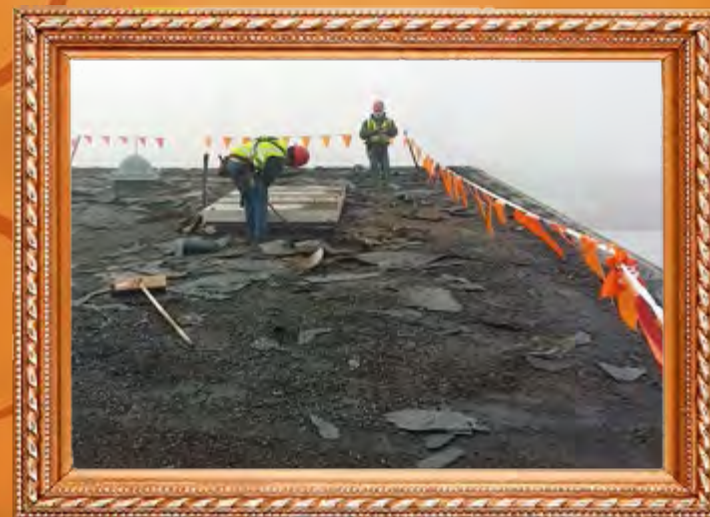
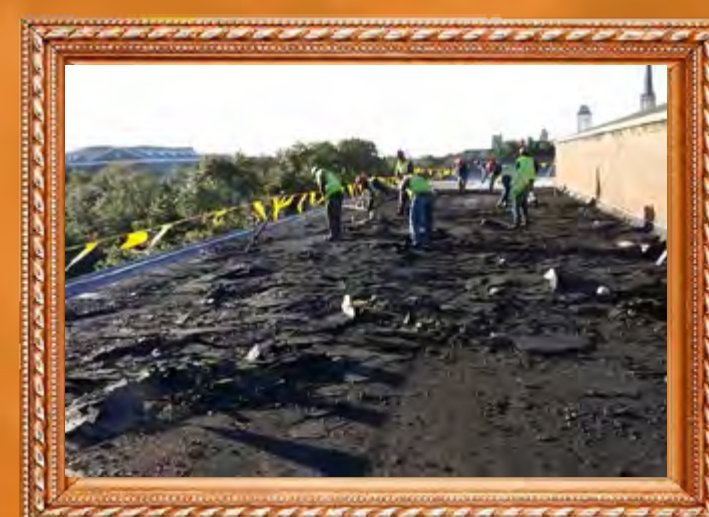
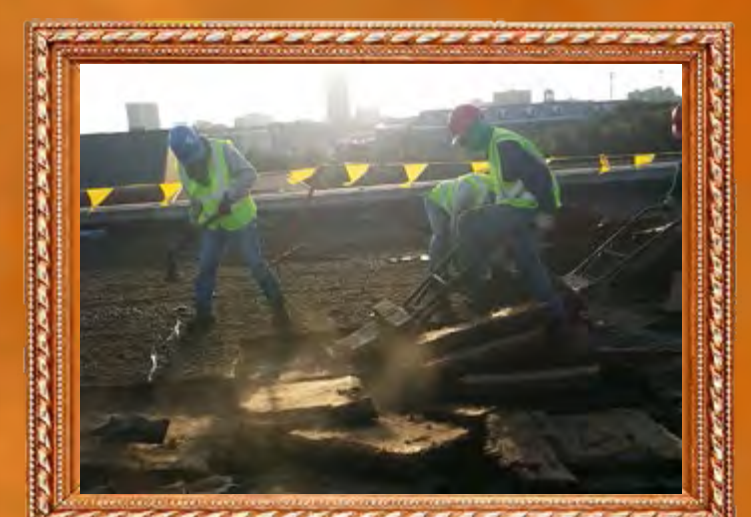
The existing roof system consisted of multiple coal-tar pitch with a flood coat and gravel surfacing. Coal-tar roof systems are particularly difficult to remove in re-roofing projects such as this project. The coal-tar has a low softening point which causes the pitch to “run” in hot weather. Therefore, no demolition can realistically occur during hot days because the pitch turns into a “gooey” mess. Another aspect is that as the pitch roof system is removed it generates airborne particles that are irritating to the skin and specially so if there is sweat present. Special safety gear is worn to protect from this irritant. The above coupled with the logistics of the many multiple roof areas and the need to double and triple handle the debris made for a very difficult tear-off scenario.

Because this roof system’s adhesive, the coal-tar itself, has a low softening point, it tends to soften and “melt” during hot weather. Therefore, the lightning protection cables dug into the pitch flood coat and was actually surrounded by the pitch. Every cable was carefully removed one by one and then meticulously cleaned to remove the coal-tar for reapplication once the new roof system was made ready to receive the lightning protection.

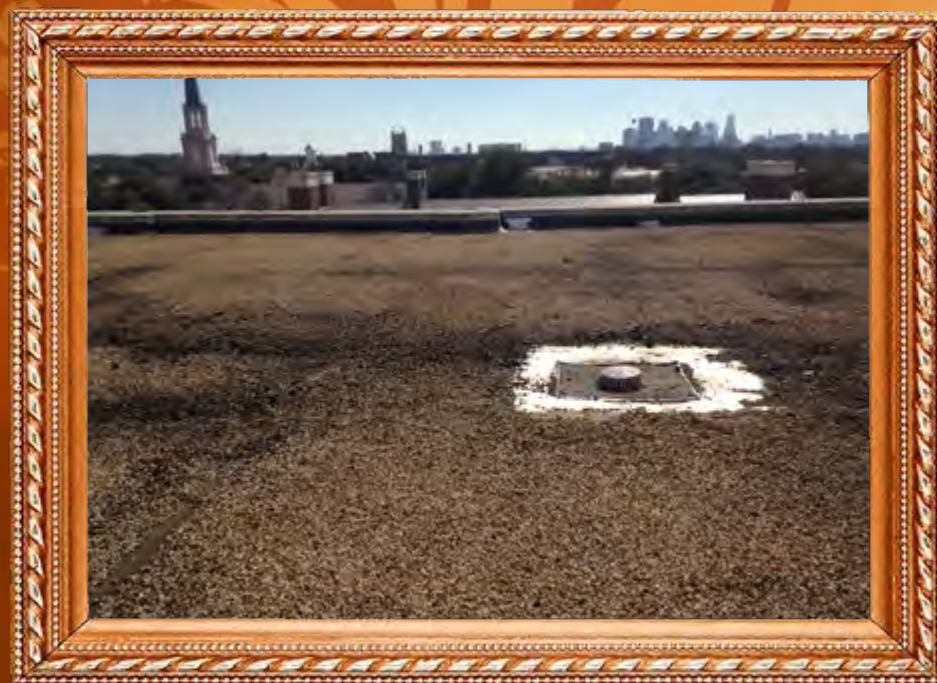
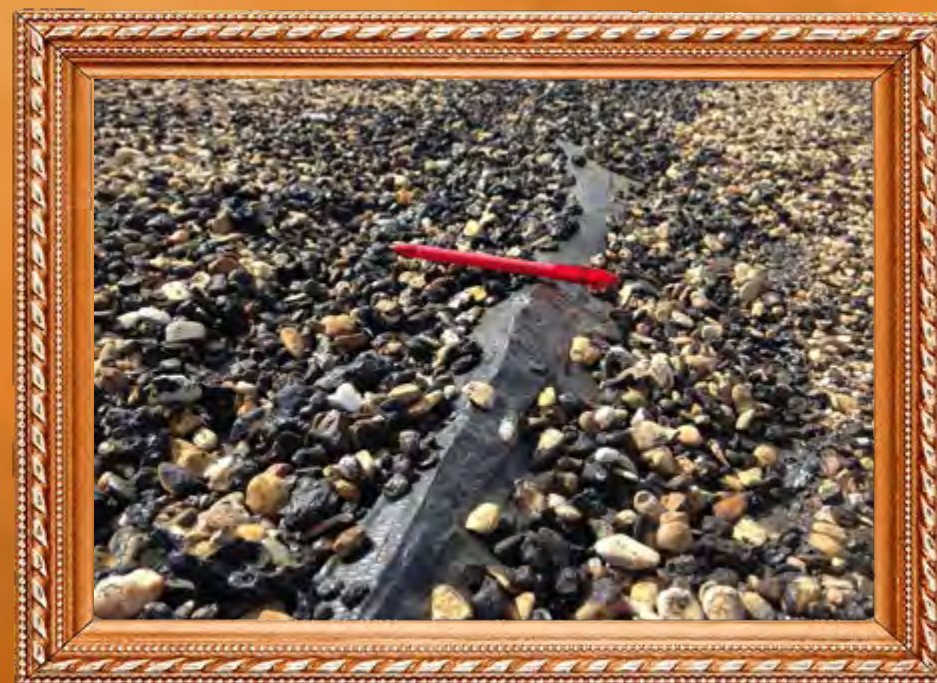
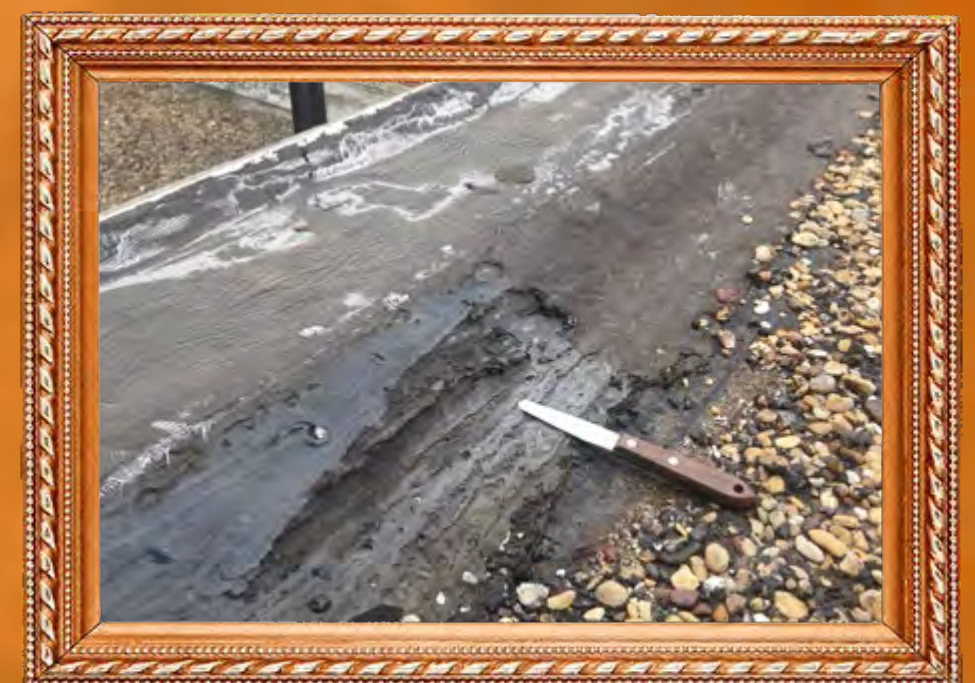
Existing coal tar pitch roof was improperly repaired causing pre-mature roof system failure

Coal Tar built-up roofing systems are considered the Mercedes of commercial roofing systems. The Coal Tar Pitch roof at Owen Art Center still had plenty of life left, but due to leak repairs being done incorrectly by other roofing contractors (using asphalt materials, leaving the felts exposed to the sun and not repairing the roof leaks) throughout its history caused the roof to fail prematurely.
